A C-117D Ditching off of Guam **August 14, 1978**

By Seth P. Washburne

A C-117D Ditching off of Guam

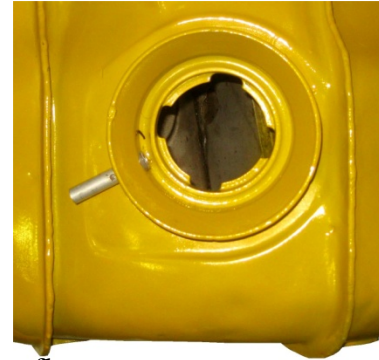
Pictured above left is a DC-3 rights-side oil tank, the same as in the R4D. The tank sits under the nacelle, above right, behind the engine. The filler neck is underneath the access panel, above right. The filler neck is shown at right. If oil spills around the neck during filling, it will go out the drain pipe, which connects to an extension, and out through the overflow drain above. The following is of note, as shown in part above.

- There is plenty of room for expansion and foaming without it having to overflow - The filler cap is on the side, and one can only fill the tank to the bottom of the neck.
- The cap area drain cannot hold more than about ¼ quart of oil, and would be a mess.
- Once the cap is closed, it is impossible for oil to leak out of the tank. Douglas did not design the plane for oil to vent all down the wing every time it is overfilled and heats up. As noted on page 24, on the prior two flights, August 10 and 13, oil gushed out, but only after landing and the oil cap was unscrewed, not while in flight.
- The oil tank does not have a vent at the access panel or filler cap.

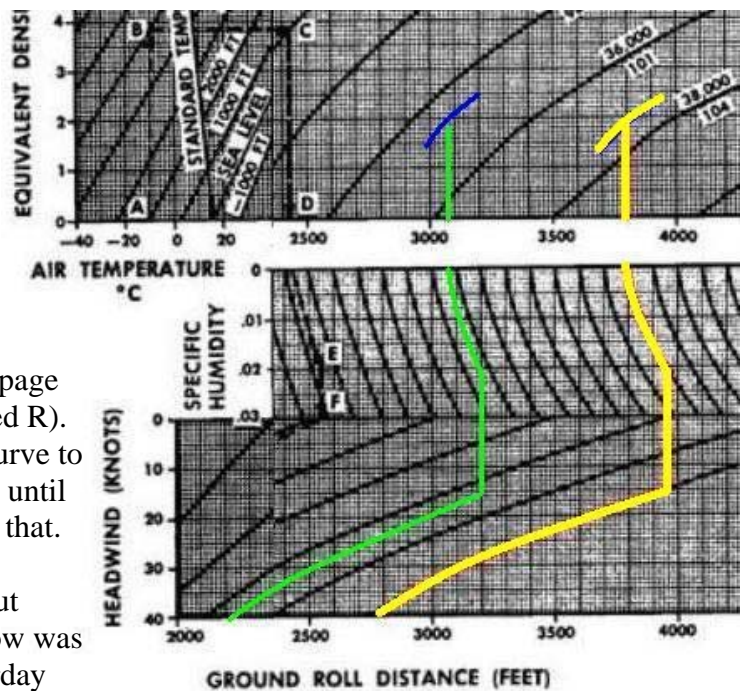
The C-117D 1971 NAVAIR Flight Manual on page 11-22 has the chart at right (with the left axis shifted R). One starts at the bottom at 2800 feet, follows the curve to the horizontal line for a 15 knot headwind, goes up until they reach a specific humidity of .021, and follows that.

The temperature at takeoff was not recorded, but historical data for Guam indicate for this day the low was 77° (at 6 a.m.) and high 88°, and based on the interday patterns the temperature at the takeoff time of 9:49 a.m. would have been 84°, 29° C. As shown later, the density altitude was 1800 feet. Following the yellow line up to this, one reaches an implied curve (drawn in, also yellow) at about **37,200 lbs.** Had he been at 34,619 lbs., the green line shows he would have taken off in about 2,200 feet.

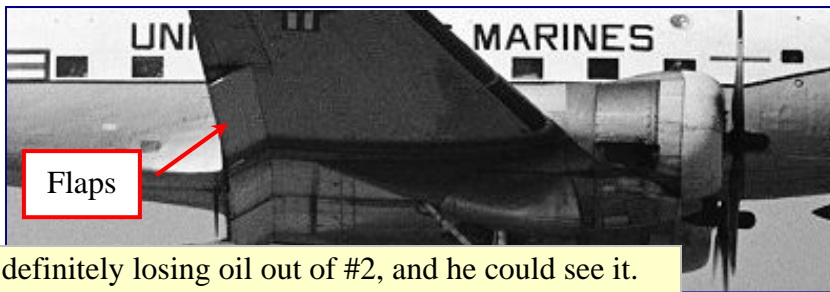
After two hours of flight, they would have burned 70 gph x (2+1) = 210 gallons x 6 lbs/gal = 1260 lbs, and so weigh 35,940, and be close to 36,000 lbs. The graph at the top of this page was for 36,000 lbs, so the weight alone was not the problem.

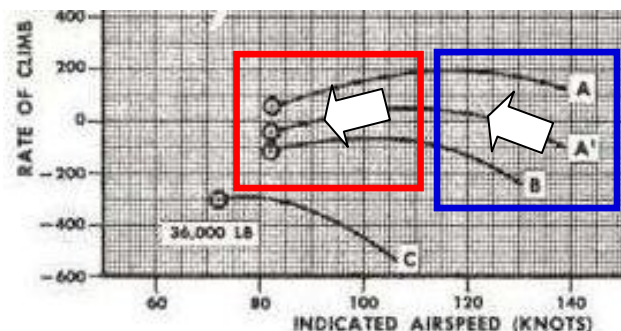
When a pilot raises the nose of an airplane, the airplane slows, but usually has greater lift, and so goes up. This is reflected in the graph at right (from page 60), in the blue box. As airspeed, on the bottom axis, decreases, the rate of climb, on the left axis, increases.

As the graph shows (arrows added), as the airspeed declines, the rate of climb eventually levels off, and then starts to decrease. The area in the red box is called “the region of reversed command,” because pitching up [a command] has a reversed affect: rather than increase lift, it decreases lift. To maintain altitude, Estes continued to pitch up. If he lowered the nose a bit and pitched up less, he would have had *more lift*, and *more airspeed*. The investigation determined that Estes and Bell entered this region, and failed to recognize it. Estes recalled this mistake:

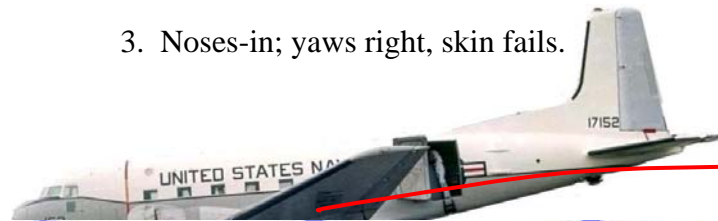
3. Noses-in; yaws right, skin fails.

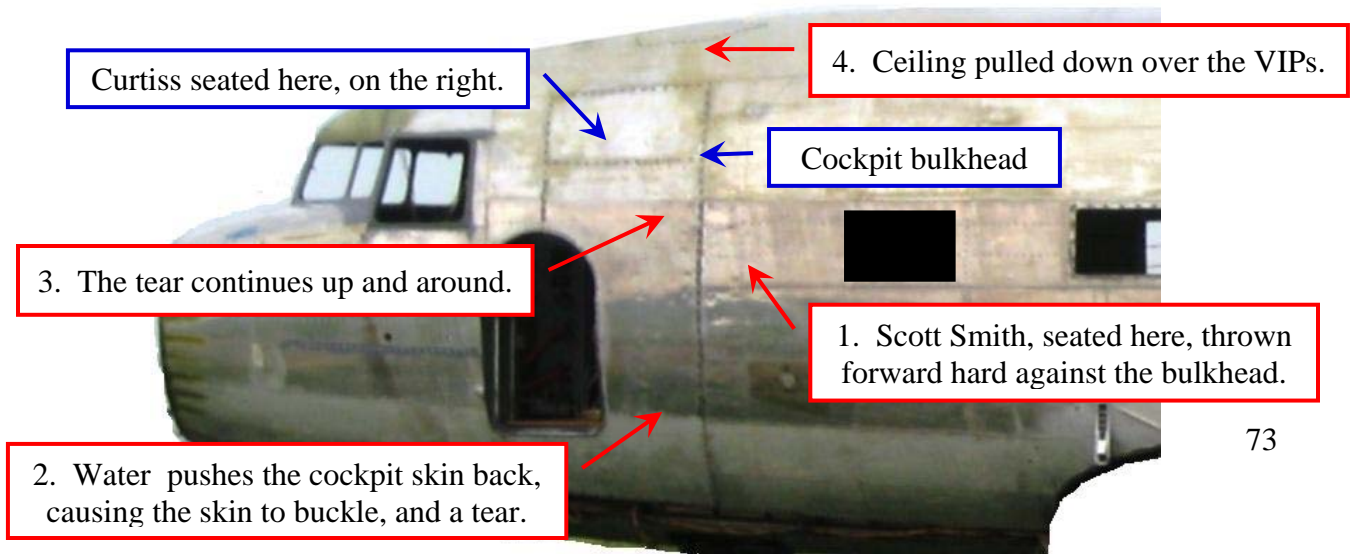
1. Upon the second impact, accentuated by the airplane yawing right, the band members slide forward against Smith, with a strong force against the cockpit bulkhead.
2. Water pushes the cockpit skin back, and it buckles forward of the cockpit bulkhead.
3. The tear continues up and around to the other side. The 3/32"-Al tears easily (right). The terrible noise everyone heard was the metal being ripped apart.
4. The nose, pulled forward, pulls the ceiling down over the VIPs.
