A C-117D Ditching off of Guam **August 14, 1978**

By Seth P. Washburne

A C-117D Ditching off of Guam

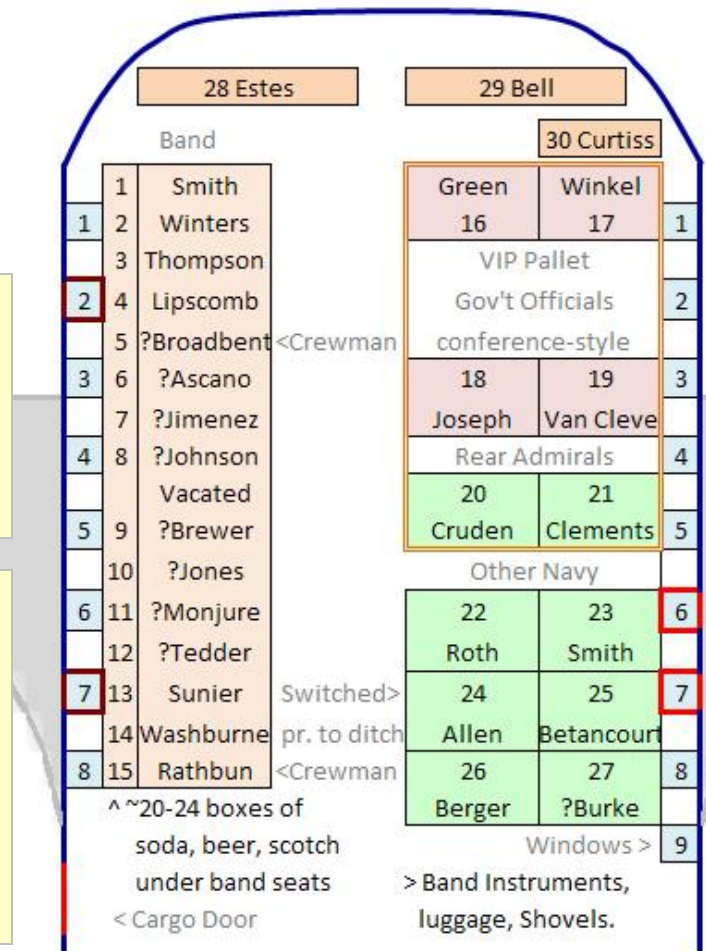
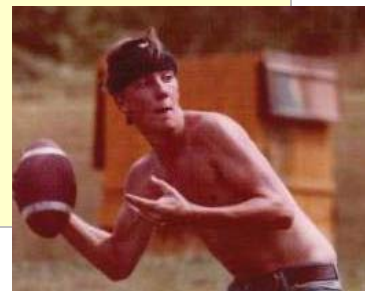
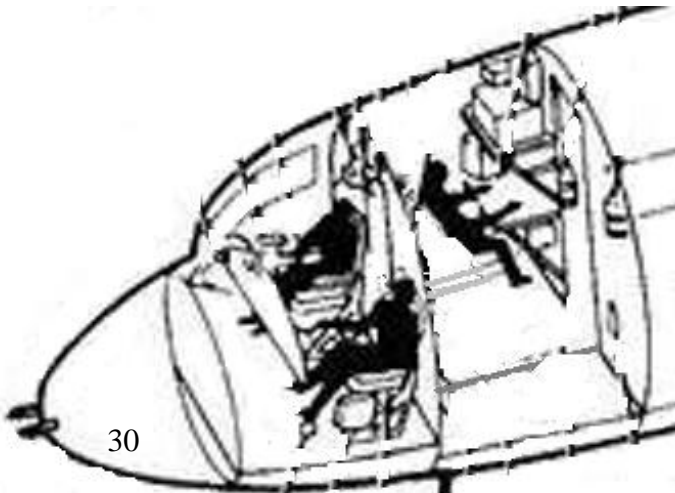
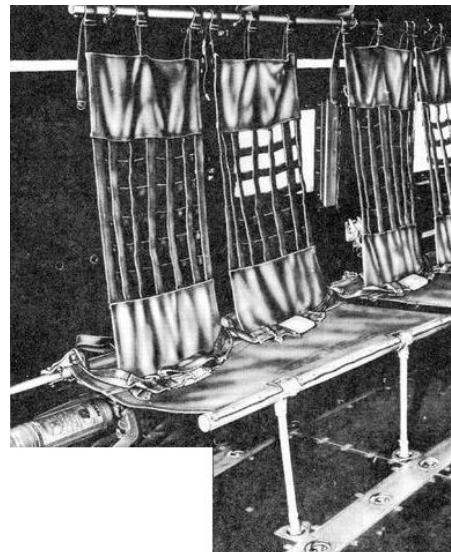
Below left (with leader lines from the manual deleted), behind the pilots was a narrow section for a crewman to sit, on the right side, by a window. This was the ditching station for the crew chief, Ron Curtiss. According to Dan Arnes, this was a very small space, and the left side was closed off at the aisle (not open as shown below), with only an outer panel of circuit breakers visible to the crew chief. Below right is what the troop seats looked like on which the musicians sat. The boxes of soda, beer, and scotch were stored beneath these seats.

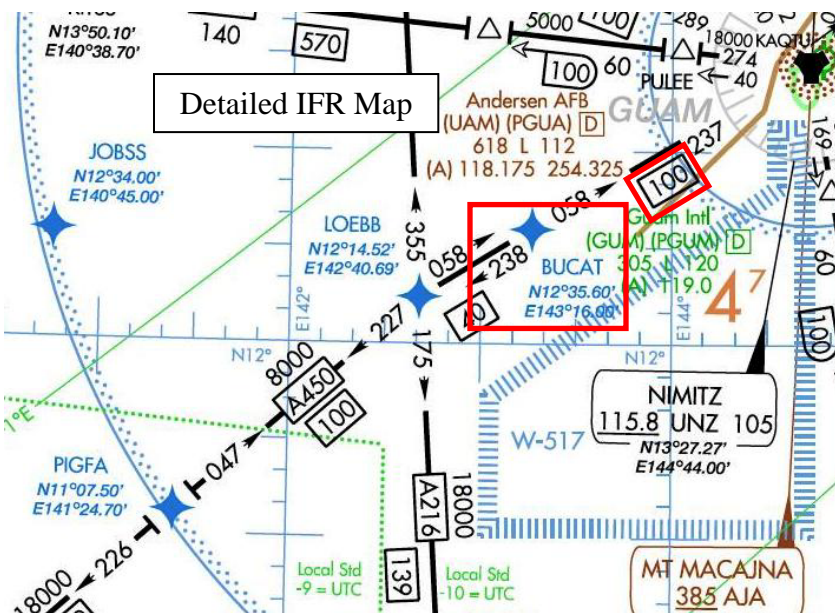
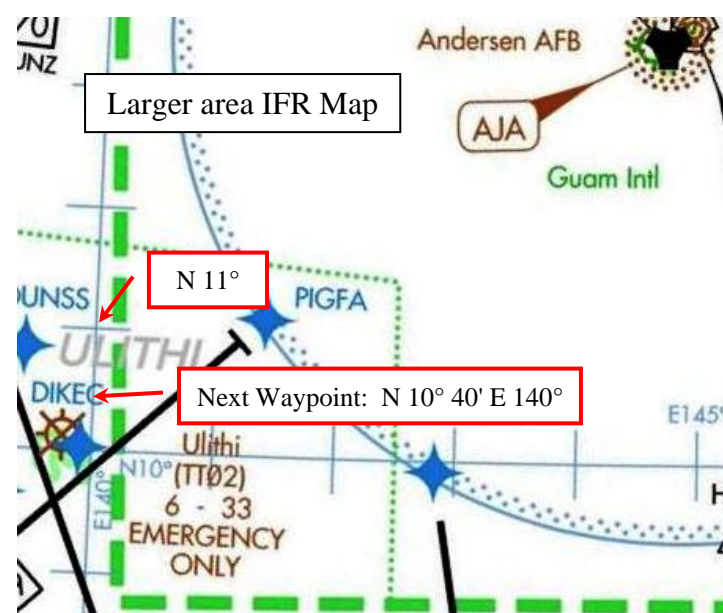
In 2013 the CORRS intersection was not listed on the IFR route map for Guam, below left, appearing to have been replaced by BUCAT. CORRS (12° 38' 14" N 143° 14' 36" E) would have been 2.5 nautical miles north and 1.5 nmi. west of BUCAT (1 arc minute=1 nautical mile). After CORRS they turned left 4° to a 234° heading. The next planned waypoint, below right, was on the 140° E longitude line, at 40' above 10° N, by the “C” of DIKEC.

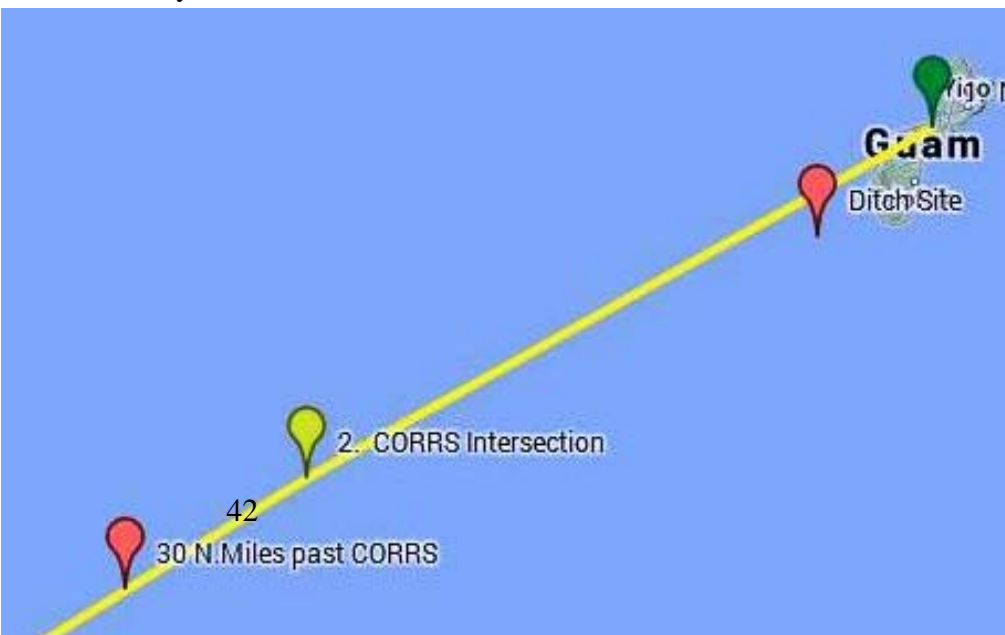
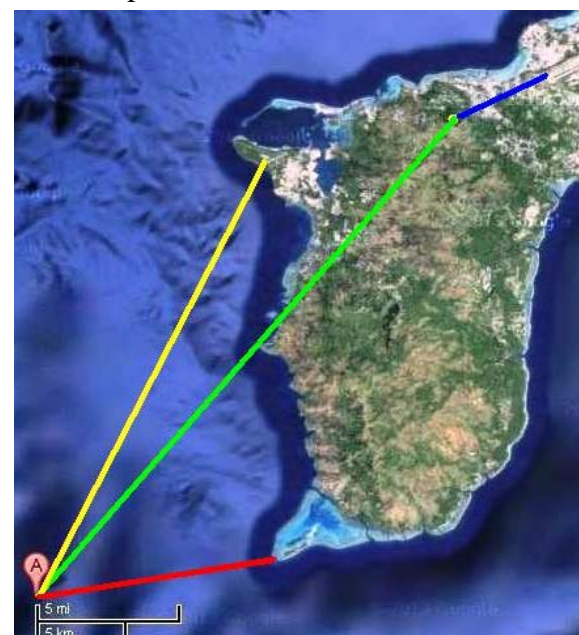
The plane ditched at 13°12.8' N, 144°30.9' E, marked below. This was 20 miles along the 232° radial, the green line below right, from the NAS Agana (Nimitz) VORTAC, and 3 more miles along the blue line to the field, 23 miles from NAS Agana. It was about 16 miles, the yellow line, from Orote Point. It was 8 miles from the island at the south tip of Guam.

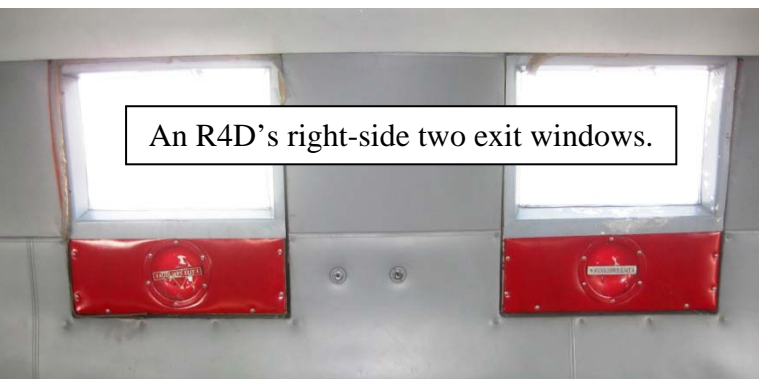
An R4D’s right-side two exit windows.

As diagrammed above, the main exit was the left rear door, but the C-117D also had four windows that could be pushed out for passengers to exit. The windows on the left were blocked by the troop seats. Windows 6 and 7 on the right, similar to those pictured below for an R4D-6, were used. Window 6 opened onto the wing, and 7 onto the edge of the wing, mostly the water.

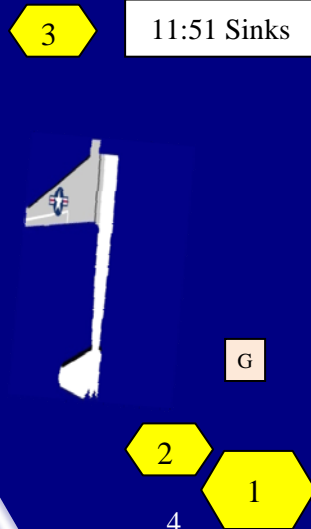
1. Impact 11:41 a.m., heading is 52°, wind 240° at 15 knts.
2. The horizontal (tail) and part of wings below the water.
 #1 (20-man) raft falls out, uninflated, drifts to right side.
 #2 (7-man) tossed out uninflated, drifts to right side.
 #3 (7-man) is tossed out, inflated on right side, filled.
 Bell goes over right wing to #1. Estes, Green on wing.
 Van Cleve says >12 on right; she and Tedder swim away.

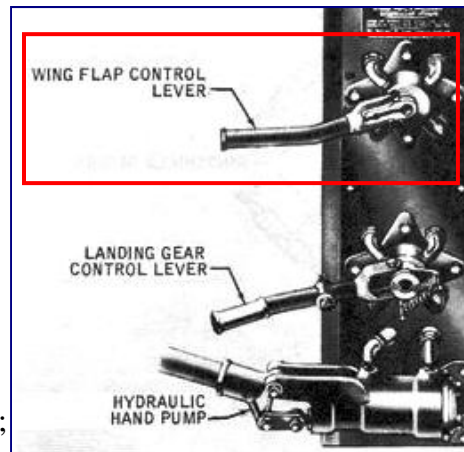
Copilot Lt. Bell: “[Curtiss] said we were definitely losing oil out of #2, and he could see it. He said it was coming from under the wing. He said there was oil all over the flap. I wanted to ask him to correct what he said, because the flaps were up and you can’t see the flaps. Thinking about the airplane not being able to fly out with all that gross weight, I was just wondering if in the flailing around in the cockpit someone could have hit that flap lever and the flaps could come down a little bit, and made more drag that we should have had. I think what he meant was it was coming off the trailing end of the wing where the flaps are.”

Pictured above is the subject C-117D, #152, when operated by the Marines, showing the flaps down. Bell’s quote above points out that one cannot see the flaps when they are up, and so for Curtiss to have seen them, they must have been down. The flap handle is located as shown at right. This is on a bulkhead behind the co-pilot, so the co-pilot reaches with his left hand behind him to push this lever down.

It is unlikely the flaps were lowered, though, because:

- the handle is out of the way, so not easily bumped into;
- it requires some force to move this handle down;
- the plane would have descended even faster with any flaps down;
- the investigation concluded the flaps were up.

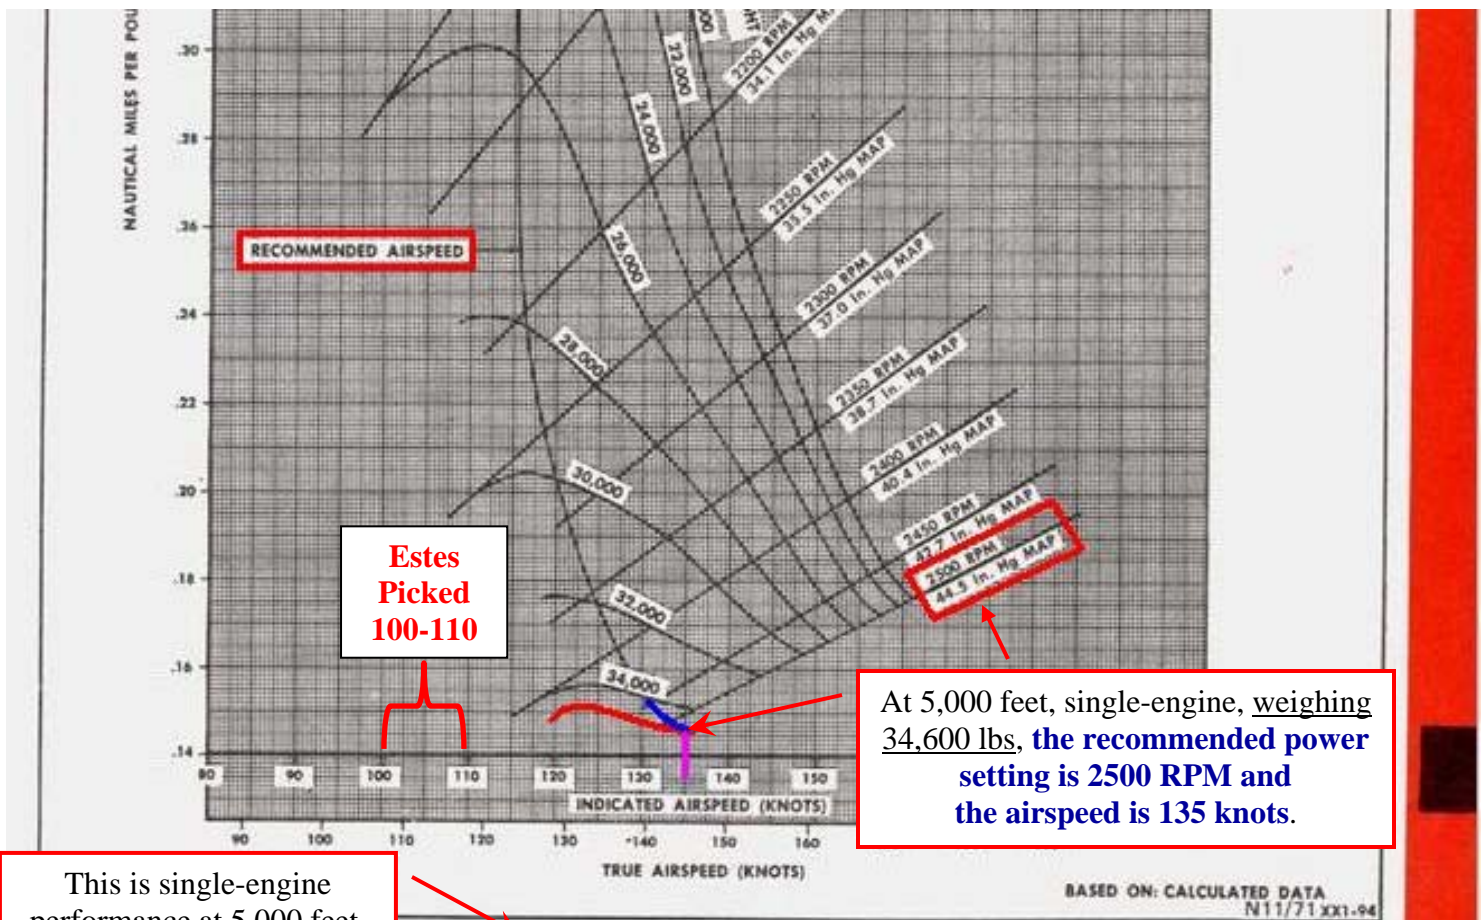
Figure 11-33. Single-Engine Specific Range – 5000 Feet

The Flight Manual’s chart for single-engine performance at 5,000 feet, its Figure 11-33, on page 11-47, is shown in part below. On the left are miles per pound of gas remaining, and on the right are curves for various gross weights, and power settings, in RPM and inches of Mercury.

At the 34,619 lbs. Bell estimated for his weight, he should have imagined a line below the 34,000 line, as added here, and estimated where this crossed the Recommended Airspeed line, and noted a recommended speed of about 135 knots. Estes said he was at 2500 RPM.

As quoted on page 36, at 5,000 feet Estes pitched for 115 knots, but slowed to 100-110.

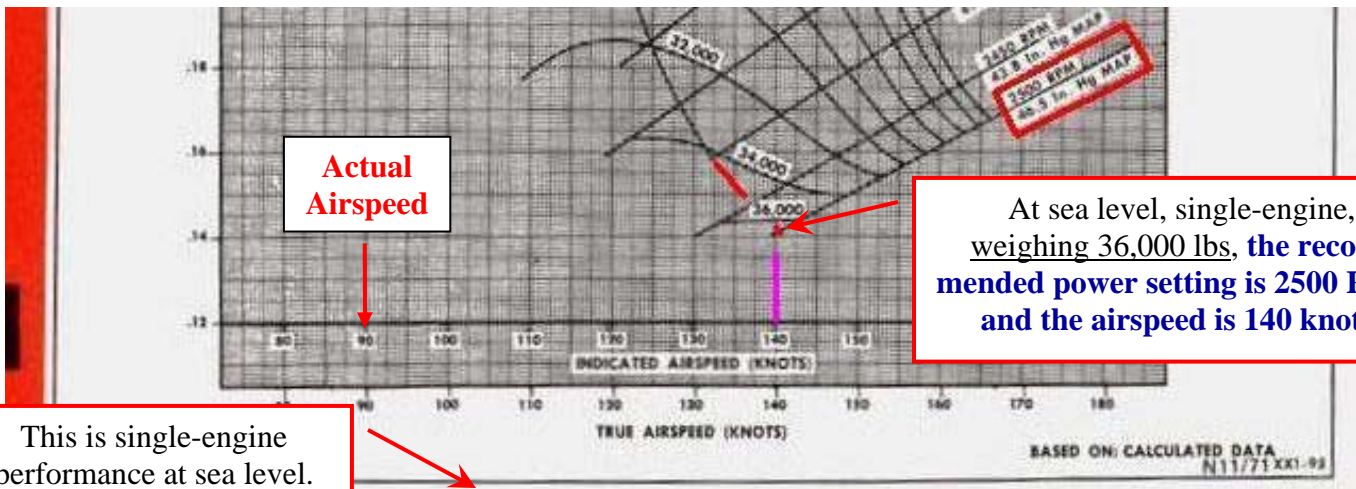
Figure 11-32. Single-Engine Specific Range – Sea Level

The Flight Manual’s chart for single engine performance at sea-level, rather than 5,000 feet as on the prior page, its Figure 11-32 on page 11-46, is shown in part below. The recommended airspeed is 140 knots, at 2500 RPM. They were at 2500 RPM, but pitched for 90 knots.

Bell states on page 39 that when near sea level at 500 feet he went to 2800 RPM, and achieved 90 knots. This would have been enough to, as shown in the table on page 60, achieve a 100 FPM climb on a standard day, but on this day it was not enough.

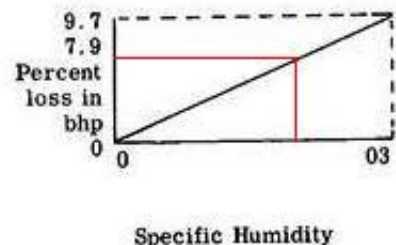
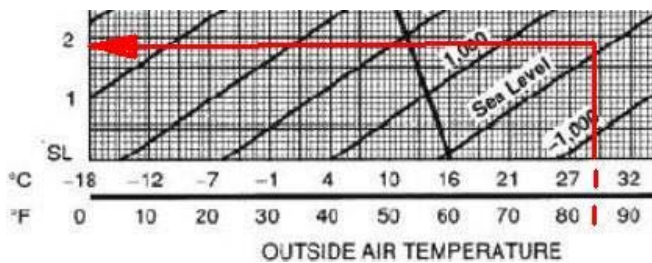
Bell indicated at the bottom of page 28 that the Kadena C-117D pilot cautioned him about the effect of humidity and temperature, that he rarely took into account before. The Flight Manual on Page 11-4 has the diagram at right. At the .021 humidity that day, the red line shows the engine horsepower would be reduced by about 7%. Therefore when he went to max power at 46" Hg, it was equivalent to only 42.8' Hg, just normal power.

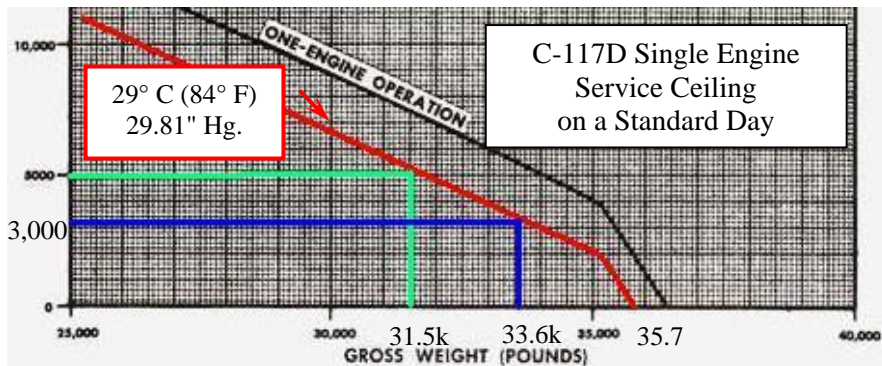
Bell was correct that airplanes perform better at lower altitude. The graph above right, from the Flight Manual, page 11-29, shows the “service ceiling” at which a climb of 100 fpm can be maintained with “normal power” operation (1800-2150 or 2500 RPM). As the altitude, on the left, goes down, the weight of the airplane that can be supported, on the bottom axis, goes up.

The top line in the chart is for a standard day. A second line in red is added to adjust for the density altitude on August 14, 1978. When Bell was at 5,000 feet, the green line shows a weight of only 31,500 could be supported, so he sank. At the 34,619 lb takeoff weight Bell estimated, an estimated 33,600 when about to ditch, the blue line shows he should have had a ceiling of 3,000 feet. The maximum weight at which he could climb at 100 fpm at normal power is 35,700 lbs. But the weight this author estimated (at the bottom of page 60) for when about to ditch of 36,000 lbs. He might maintain altitude (not climb), though, and do better at max power. Thus it appears that temperature was a key factor.

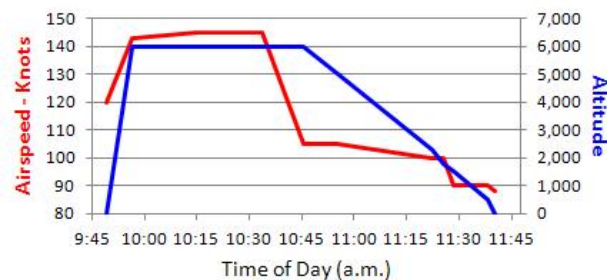
Details from the timeline on page 58 and accounts are input in the table below, which adjusts for a 15 knot headwind, and then a tailwind. They ditched 23 miles from where they departed. Their altitude and airspeed are graphed at right.

The C-117D ditched because:

- a) It was too heavy to maintain altitude at normal power, due to it being a hot and humid day.
- b) When lower and lighter, max power was reduced by humidity, and it was too slow.
- c) The range was decreased by entering the region of reversed command, where they had less lift, and less airspeed. They descended for 1 hour and 3 minutes at an average 101 kts. If they averaged 14 knots more, 115 knots, they could have landed at Orote Airfield. At 115 knots plus the 15 knot tail wind, they would have reached Orote in 7 minutes.

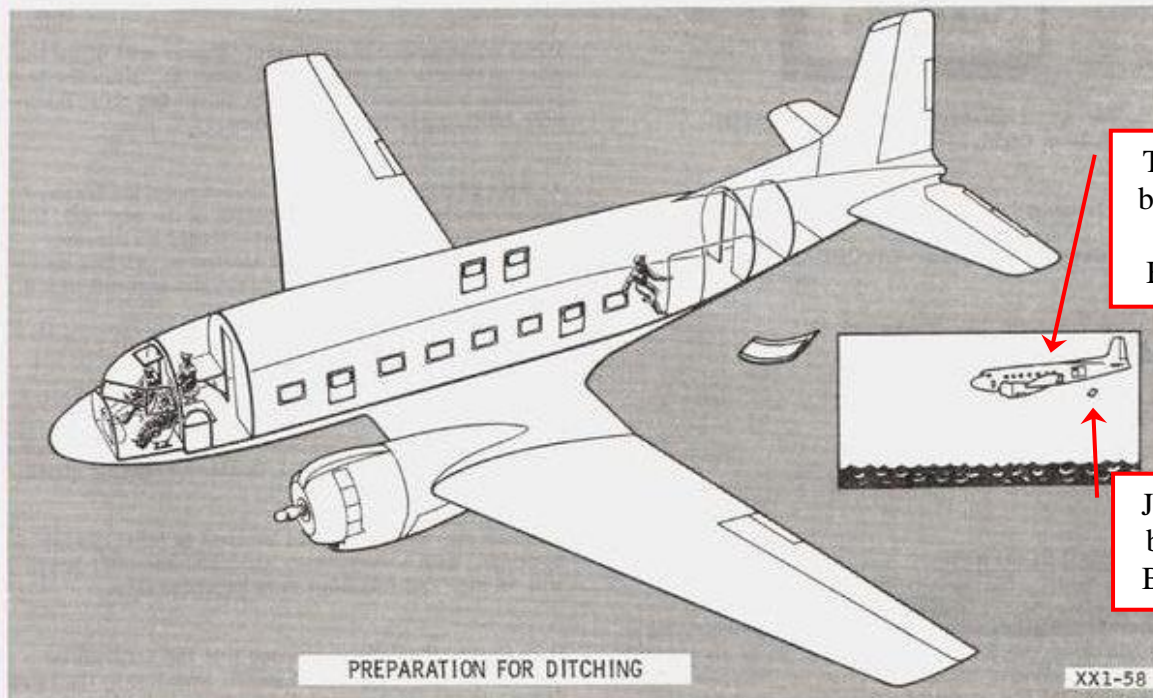
Figure 5-2. Preparation for Ditching

The nose should be pitched down, but Estes and Bell pitched up.

Jump door should be jettisoned, but Bell reinstalled it.

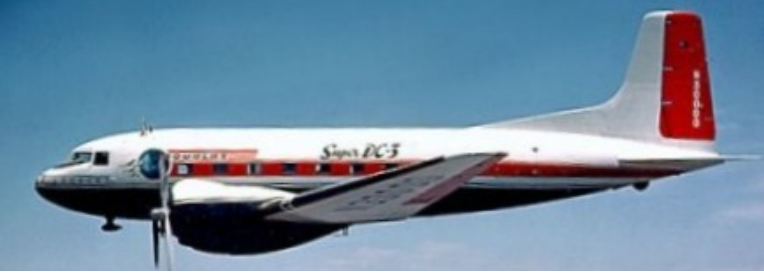
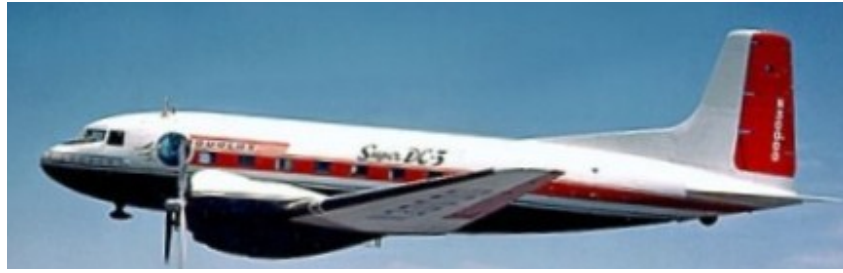
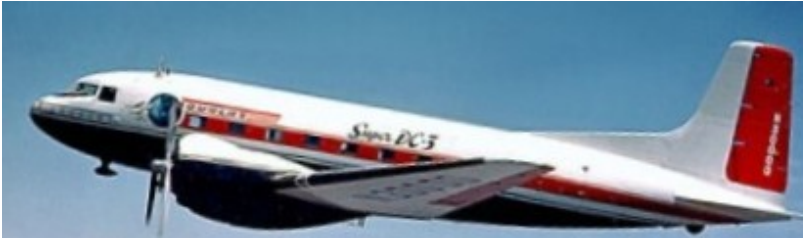
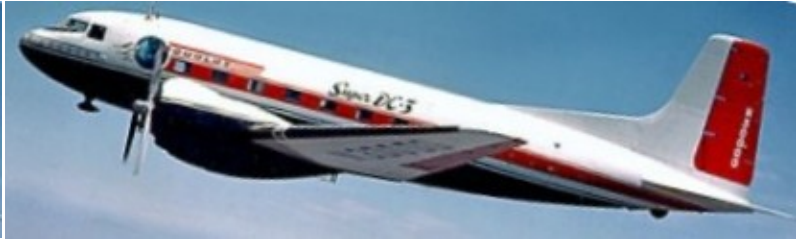
Below is the profile of a Super DC-3. When pitched up by the 5° specified for ditching in the flight manual, #7 on page 67 herein, the tail will touch after the landing gear doors.

The specified ditching angle, a pitch of 5°

Below: 10° - tail and gear housing hit the same time.

One needs 15° for the tail to hit first by seconds.

These angles are shown again below for the actual plane, C-117D #17152 (from a photo on the ground). At 5° the gear housing would hit first; at 10° the gear and empennage. The only way to get a 3-4 second delay after the tail hitting, and severe hit, would be with about 15°.

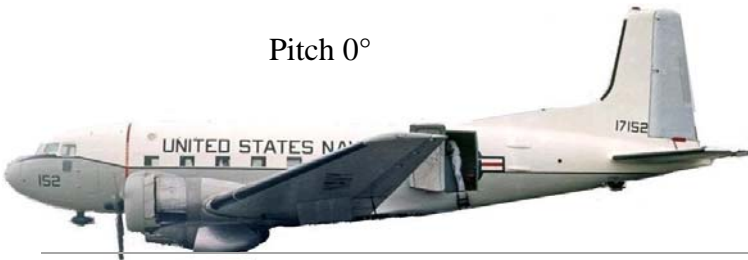
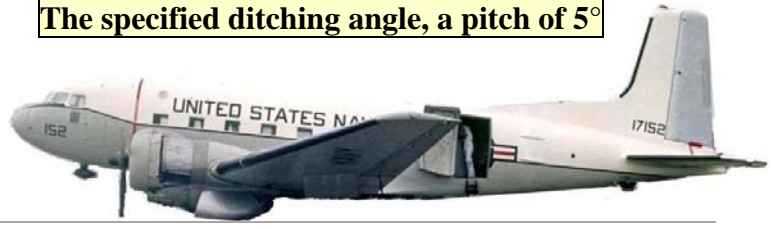
Pitch 0°

The specified ditching angle, a pitch of 5°

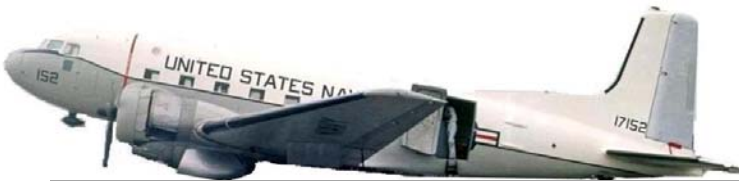
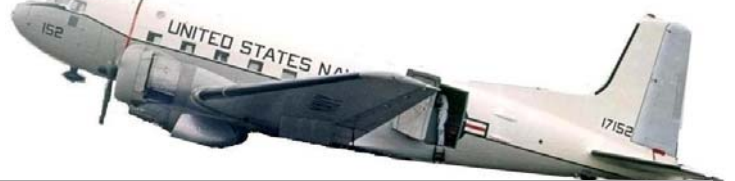
Below: 10° - tail and gear housing hit the same time.

One needs 15° for the tail to hit first by seconds.

Bell and Estes probably pitched up at 15°, three times the specified angle.

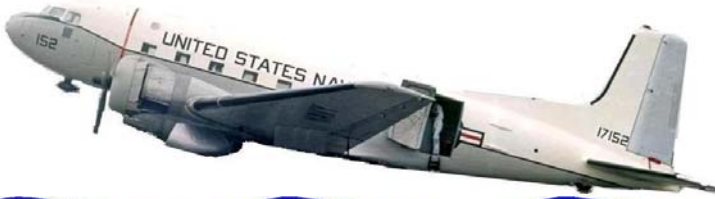
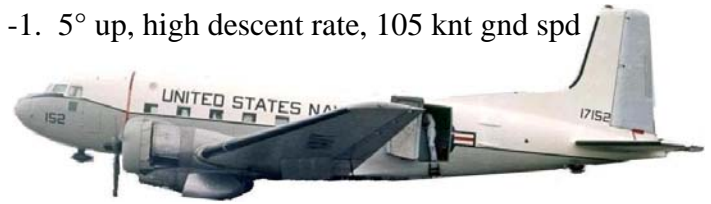
0. Pitches up 15° prior to impact.

-1. 5° up, high descent rate, 105 knt gnd spd

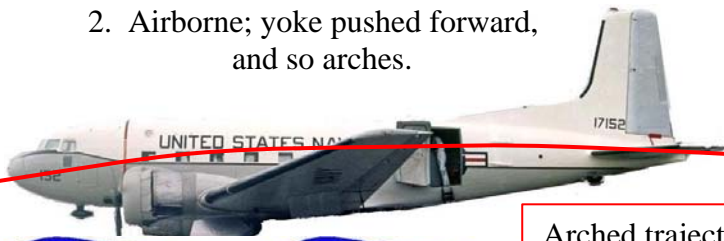
2. Airborne; yoke pushed forward, and so arches.

1. Tail hits water.

Arched trajectory after impact

4. Hits two more wave crests; water friction drags the cockpit off completely.

3. Noses-in; yaws right, skin fails.

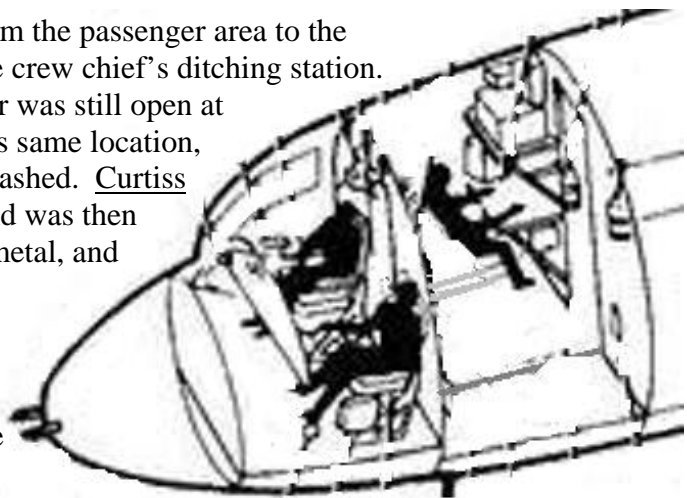
In the cockpit diagram at right, a door from the passenger area to the cockpit opened to the right, covering over the crew chief's ditching station. The quote above from Bell indicates this door was still open at impact. WWII radio operators who sat in this same location, worried they would be trapped if the plane crashed. Curtiss may have taken this risk to help the pilots, and was then trapped behind the door, or pinned by other metal, and drowned.

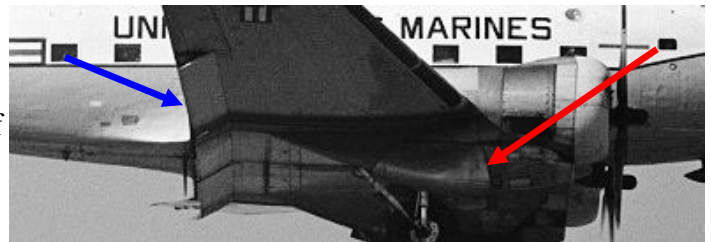
[The photo at right of airplane 17152 when with the Marines shows the view (red line) from the crew chief window did not include the flaps, so Curtiss would have seen this from an aft window, the blue line.]
